# Aviation Investigation Preliminary Report

<b>Location:</b>	Orlando, FL	<b>Accident Number:</b>	DCA25LA065
<b>Date &amp; Time:</b>	December 21, 2024, 18:30 Local	<b>Registration:</b>	UNREG
<b>Aircraft:</b>	Uvify IFO	<b>Injuries:</b>	1 Serious
<b>Flight Conducted Under:</b>	Unknown

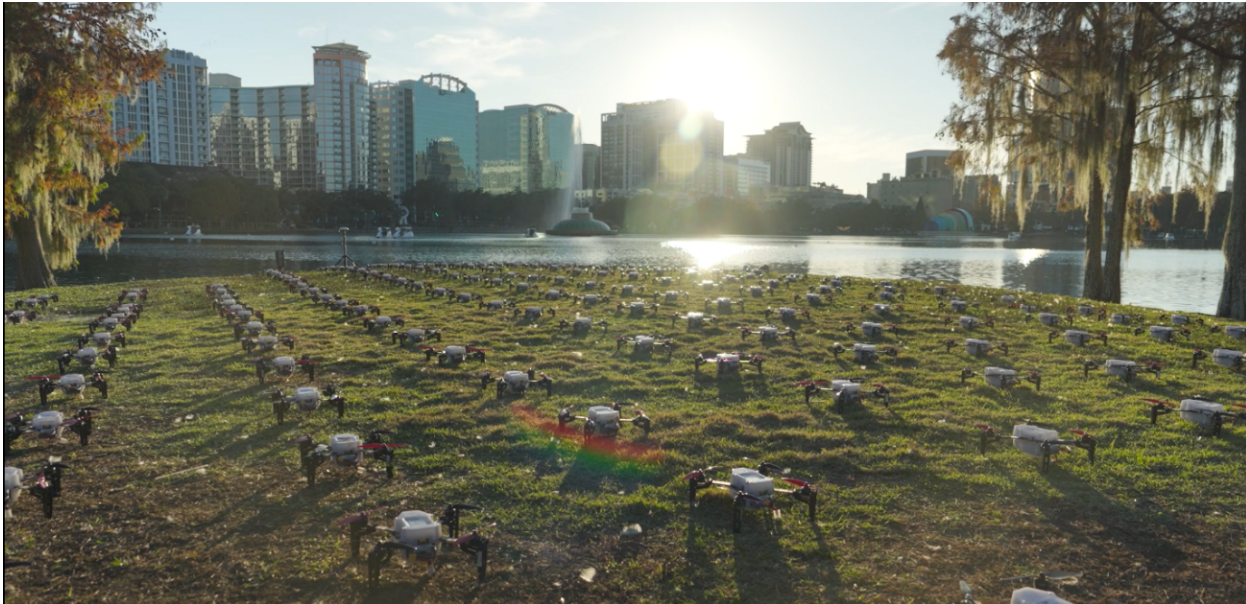
**Figure 1.** sUA setup at Lake Eola. (Source: Sky Elements LLC)
